Crack propagation and fracture in silicon wafers under thermal stress

Andreas Danilewsky,^{a*} Jochen Wittge,^{a‡} Konstantin Kiefl,^a David Allen,^b Patrick McNally,^b Jorge Garagorri,^c M. Reyes Elizalde,^c Tilo Baumbach^d and Brian K. Tanner^e

The behaviour of microcracks in silicon during thermal annealing has been studied using *in situ* X-ray diffraction imaging. Initial cracks are produced with an indenter at the edge of a conventional Si wafer, which was heated under temperature gradients to produce thermal stress. At temperatures where Si is still in the brittle regime, the strain may accumulate if a microcrack is pinned. If a critical value is exceeded either a new or a longer crack will be formed, which results with high probability in wafer breakage. The strain reduces most efficiently by forming (*hhl*) or (*hkl*) crack planes of high energy instead of the expected low-energy cleavage planes like {111}. Dangerous cracks, which become active during heat treatment and may shatter the whole wafer, can be identified from diffraction images simply by measuring the geometrical dimensions of the strain-related contrast around the crack tip. Once the plastic regime at higher

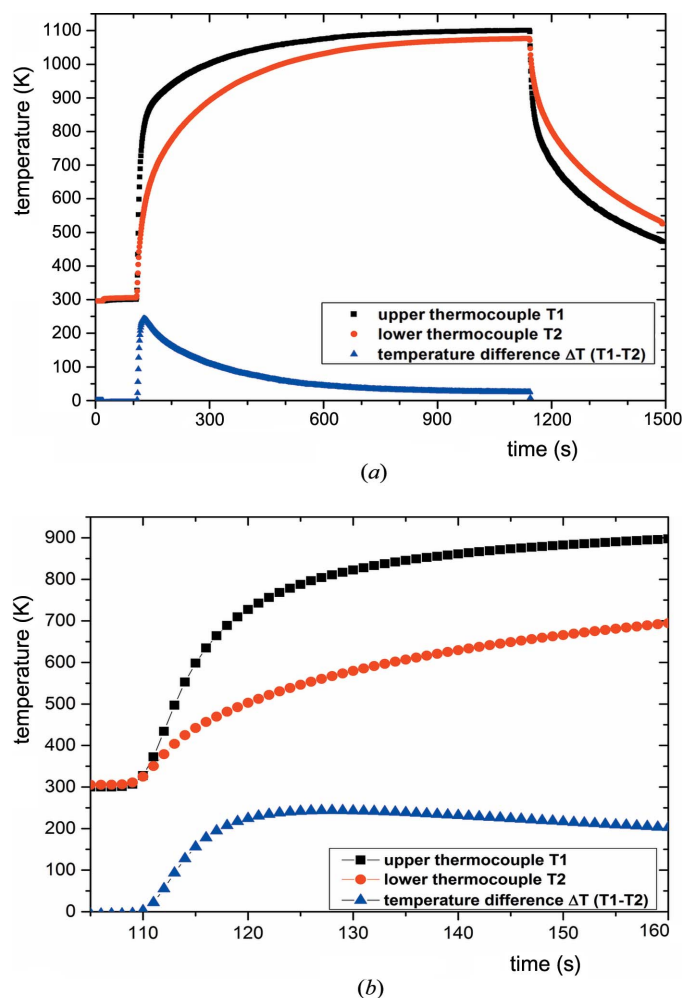
Figure 1

(a) Full timeline of the first heating of wafer 0110. The temperature was measured every second. (b) Beginning of heating with higher time resolution. The crack opens at a temperature of 598 K, *i.e.* for a temperature difference ΔT of 155 K between the two thermocouples. The side crack was generated between 893 and 895 K, with $\Delta T = 204\ \text{K}$ at about 155–160 s.

The temperature was measured with two thermocouples in contact with the back side of the sample situated near the centre and 6 mm below. Fig. 1(a) shows the typical heating profile used for the first heating sequence and Fig. 1(b) the first 50 s of the heating with higher time resolution. The applied RTA heating rate is the same as in plateau annealing but much slower than in flash annealing methods. The data relate to the experiment that corresponds to the movie available as supplementary material¹ (from which the series of single topographs shown in Fig. 3 below have been taken). A second, similar, heating sequence was applied to observe the formation of slip systems at different positions along the cracks.

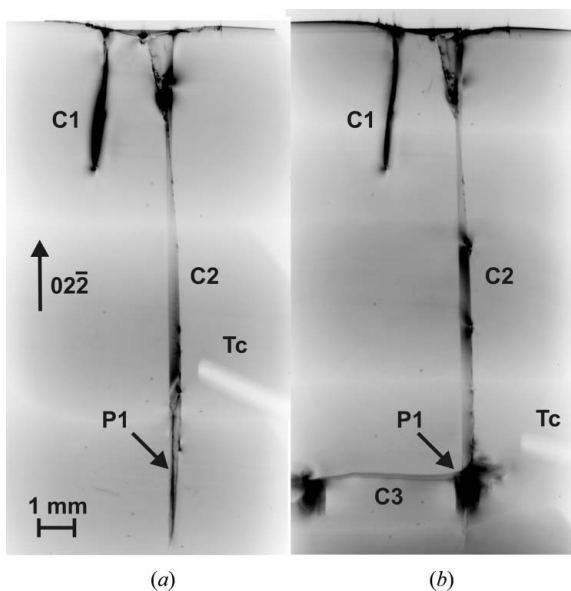
Figure 2

Transmission topographs of two cracks introduced from a 50 N indentation at the wafer edge, 90° from the notch: Tc indicates the shadow of a thermocouple, P1 the position where crack C3 originates (room temperature, view from the back side through the sample). (a) Before the first heating sequence. The left crack C1 is short and shows a substantial strain field at the tip of the crack for which $\kappa = 20$. The more dangerous crack C2 is almost four times longer and has a sharp contrast at the tip; no strain field is visible which results in $\kappa = 167$. (b) After the first heat treatment. The new horizontal crack C3 is generated. Around the crack tips dense dislocations and slip bands were produced, visible from the black contrasts.

Subcritical and critical cracks introduced by near-edge indentation are shown in the large area transmission topograph of Fig. 2(a). The shorter crack C1 on the left has a low κ value ($L/d_0 = 20$), which is below κ_c for all our experiments. It does not propagate throughout the experimental cycle and the X-ray image width decreases during the heating sequences (Fig. 2b). On the right is a longer crack C2 with a high κ value ($L/d_0 = 167$), which exceeds the κ_c value associated with the heating and cooling sequence shown in Fig. 1. As shown in Fig. 2(b), crack C2 does propagate.

The wafer's edge is heavily damaged around the indent. The first 2 mm of the crack C2 show orientation contrast from

tilted platelets cleaved by the 50 N load. By measuring the average width of the X-ray image associated with the length of crack C2 into $[0\bar{1}1]$ and comparing it with the calculated theoretical values for the crack widths from the different diffraction planes, it can be concluded that the crack runs from different $(11\bar{l})$ planes into a predominantly $(11\bar{2})$ plane. Some irregularities indicate conchoidal fracture. Since the critical crack lengths even for the narrowest images are greater than the wafer thickness, the cracks penetrate through to both sides of the wafer, except the last 2.3 mm of the tip. This ending part of the tip is not visible either at the surface by NIC or in the bulk by infrared transmission light and therefore cannot be indexed, but $\{110\}$ and $\{111\}$ can be excluded. We then expected them to be visible in reflection XRDI as well as in transmission, and careful X-ray experiments on both sides of the wafer confirmed this to be the case. The crack C3 in Fig. 2(b) appeared at relatively low temperature in the brittle regime of silicon in the perpendicular $[011]$ direction (compare Fig. 1b). This crack starts again through complex high-indexed planes capable of consuming much of the strain energy. Then it deflects for a long distance into the low-energy $(0\bar{1}1)$ plane until it ends in another more complicated plane which cannot be indexed any more.

Upon further heating, the length of the crack did not increase, but in the region of the strain fields of the stationary point at P1 and around the crack tip itself dislocations and slip bands are generated (Fig. 2b). The onset of the slip formation starts with image 0540 in the movie and it occurs at a temperature of \sim 1056 K, about 364 s after the start of the heating cycle.

the tip but also in between the front and back sides of the sample. The straight $[0\bar{1}1]$ -oriented path visible on the back side (Fig. 4*b*) as well as in the diffraction images [Figs. 2 and 4(*a*)] indicates that the crack surface oriented to this side is predominantly (011).

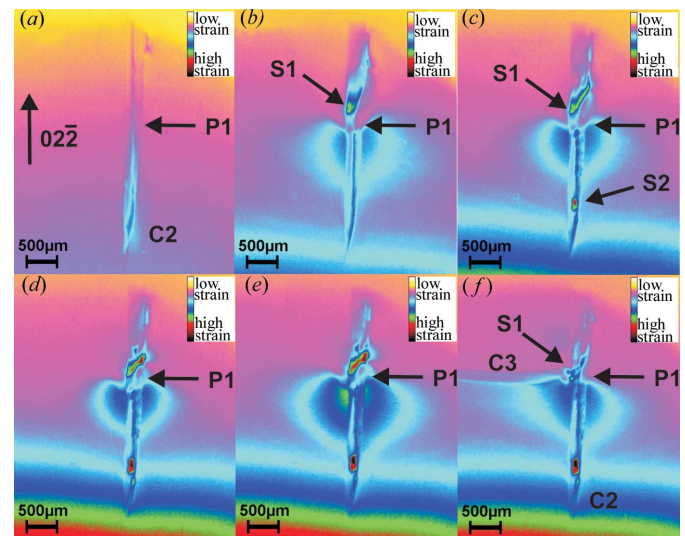
Figure 3

False-coloured X-ray diffraction images around the tip of crack C2 (detail from Fig. 2a). (a) Image 0037 at room temperature before heating of the crack C2. P1 marks the position where the opening of the crack is impeded. (b) Image 0045 at ~ 598 K ($\Delta T \simeq 155$ K). The image shows the opening crack which produces a huge strain field below P1 and a small one S1 directly above. (c) Image 0049 at 689 K shows increasing strain fields, the upper one into the $[00\bar{1}]$ direction. A small-sized strained area S2 builds up near the tip. (d) Image 0060 at 788 K shows increasing strain at S1 above P1. (e) Image 0104 at 893 K. The strain fields below and above P1 have both increased in size and intensity. The thermal stress exceeds 24.8 MPa. (f) Image 0105 at 895 K. The crack C3 has developed to the left into the $[011]$ direction in less than 0.72 s and the strain fields have significantly decreased in size and intensity.

Fig. 3 shows a series of six topographs around the tip of the crack C2. These images were taken from a movie of the whole heating process, then image processed to improve the contrast and converted into false colours for improved visibility of the

contrast related to the strain fields. In Fig. 3(a), at room temperature before heating, a higher strain is visible at the crack tip, indicated by the blue colours. This part of the crack below position P1 is inside the bulk of the wafer and not visible at the surfaces (compare Figs. 4b and 4c). Directly after heating, crack C2 opens and stops at position P1, about 2.3 mm away from the visible sharp crack tip (Fig. 3b), which can be seen in images 0038–0048 on the video of the crack development. Obviously the opening of the crack appears only for this part of the crack where the cleavage plane makes the connection between the front and back side of the wafer. In the part of the crack that remains invisible below the surfaces, a long internal boundary line between the crack and the undisturbed crystal with a length of at least 4.6 mm results. Much more energy would be needed to elongate such a buried crack than the shortest direct connection, which would be, for example, a straight $\langle 110 \rangle$ line with a length of only about 1.0 mm between the wafers surfaces. Between images 0049 and 0104 (corresponding to a temperature rise from 635 to 893 K) the opened crack remains at this position. During this period, for which the crack remains sessile, a substantial long-range strain field below P1 gradually builds up, visible as the dark-blue colours in Figs. 3(b)–3(e). Above P1 in parallel a much higher strain piles up in a very small volume S1, like a hot spot and into the $[00\bar{1}]$ direction, visible as the green–red colours. Another hot spot of strain S2 near the tip remains without consequences during the experiment.

In the next frame, number 0105 (shown in Fig. 3f), the crack C3 has developed to the left in less than 0.72 s in the [011] direction using first a number of inclined {hhl} planes to deflect into the (0 $\bar{1}$ 1) plane perpendicular to the (100) sample surface. It stopped at a point \sim 5.4 mm away from P1 after another deflection into higher-energy planes of the type {hkl}, deviating from the [011] direction. The duration for which crack C2 remained at position P1, calculated by summing the number of images, is around 40 s as the temperature increases from 598 to 893 K (Fig. 3e). It becomes obvious that the applied thermal stress was still not high enough to elongate the crack C2 into the direction of the highest gradient and the [011] direction is the more attractive one.

Comparing the strain field in false colours below the crack front, it is clear that most of the strain energy in the lattice was released as the crack bent rapidly and increased in length towards the left hand side in the X-ray image. The spatial extent of the strain field in the lattice decreased on the left hand side as well as on the right hand side of the crack C2. The lower decrease on the left hand side is most likely due to the deformation of the strain field during the development of the side crack.

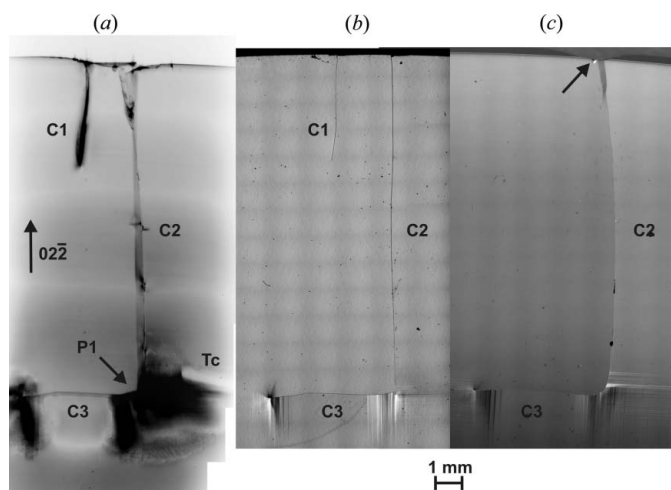
Figure 4

(a) X-ray diffraction transmission-mode image of the crack after the second heating cycle viewed from the back side through the sample, taken at room temperature. Around the tip of the initial crack and the lateral crack tip, many dislocations and slip bands have been generated. (b) Interference contrast microscopy image from the back side with cracks C1, C2 and C3 visible. Surface steps around the tips of C2 and C3 are traces of the slip bands in Fig. 4(a). (c) Interference contrast microscopy image of the front side of the same sample (mirrored). Cracks C2 and C3 are visible and the surface steps correspond to the slip bands in Fig. 4(a). The arrow on top indicates the position of indentation.

On taking the sample around the heating cycle for a second time, we observed no further changes in the crack position (Fig. 4a). Obviously the residual stress is not enough to produce another cracking. However, there was further development in the dislocation configuration at the tip of the lateral crack and at the point of branching. The extent of the high dislocation density in Fig. 4(a) is roughly twice that in Fig. 2(b), which is consistent with the sample spending twice the length of time in the temperature region where significant plastic deformation occurred.

NIC (Figs. 4b and 4c) resolves surface steps that are the traces of slip bands (Danilewsky, Wittge, Hess, Cröll, Allen *et al.*, 2011) on the front and back surfaces of the sample, and we note that they correspond well with the X-ray images. As already mentioned, not all parts of the cracks can be seen at the wafer's surfaces with light microscopy. Only on the back side of the sample are all three cracks visible (Fig. 4b). On the front side the indentation from which both initial cracks originate is indicated by an arrow, but the crack C1 is completely invisible (Fig. 4c). The crack C2 appears macroscopically more curved on the front side and 2.3 mm shorter than the value obtained by topography. The path of crack C2 on the inclined cleavage plane inside the sample is clearly different on the front and back sides. Therefore it cannot consist of one single and smooth (1 $\bar{1}$ 2) cleavage plane as concluded from the diffraction image in Fig. 2, but deflects into various planes not only from the indent on top down to

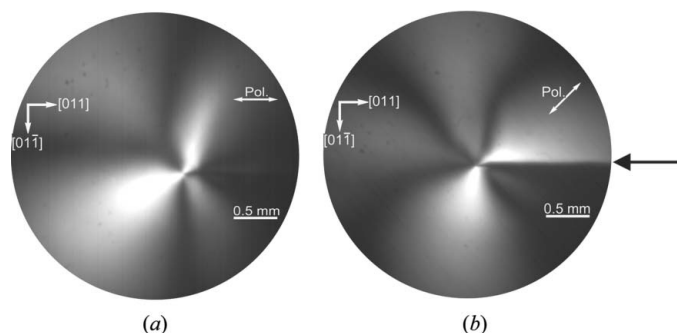
Figure 5 Polarized infrared images showing the strain around the tip of crack C3 after the second heating (black arrow indicates crack position). The asymmetric lobes indicate the inclined 60° dislocations to be the origin of the strain. (*a*) Polars parallel and perpendicular to crack direction. (*b*) Polars at 45° to crack direction.

Polarized infrared images of the strain fields around the tip of crack C3 after the second heating sequence (Fig. 5) show a long-range strain field consistent with the extent of the high-dislocation-density region. This strain field shows a highly asymmetric four-lobe contrast, somewhat similar to that expected of a super-edge dislocation. However, the strongest lobe lies at approximately 120° to the crack direction when the crossed polars are parallel (Fig. 5*a*) and perpendicular to the crack direction, and at $0/90^\circ$ to it when the polars are at 45° to the line direction (Fig. 5*b*). A contrast of $\pm 45^\circ$ for parallel polars and $0/90^\circ$ for polars in the 45° position would be expected for a super-edge dislocation (Tanner & Fathers, 1974) running perpendicular to the wafer surface, but with the Burgers vector in the wafer plane inclined at 45° to the crack length. However, the simple model of the crack tip has the super-Burgers vector at 90° to the crack, inconsistent with the results of Fig. 5. It is evident from Fig. 4(*a*) that substantial slip, assumed to consist of a high number of 60° and screw dislocations on inclined $\{111\}$ planes (Danilewsky, Wittge, Hess, Cröll, Allen *et al.*, 2011), has occurred in the vicinity of the crack tip and has modified the overall strain field. In the same way as described by Booyens & Basson (1980) for the sphalerite structure, only the edge part of the Burgers vector of the 60° dislocations contributes to the contrast, which explains the asymmetry of the lobes in Fig. 5. From this it can be concluded

that the residual strain in the polarized infrared images after the second heating is related to the dislocations and not to the crack.
